Infrared diagnostic of substation feeder problems

Mississippi Power Company

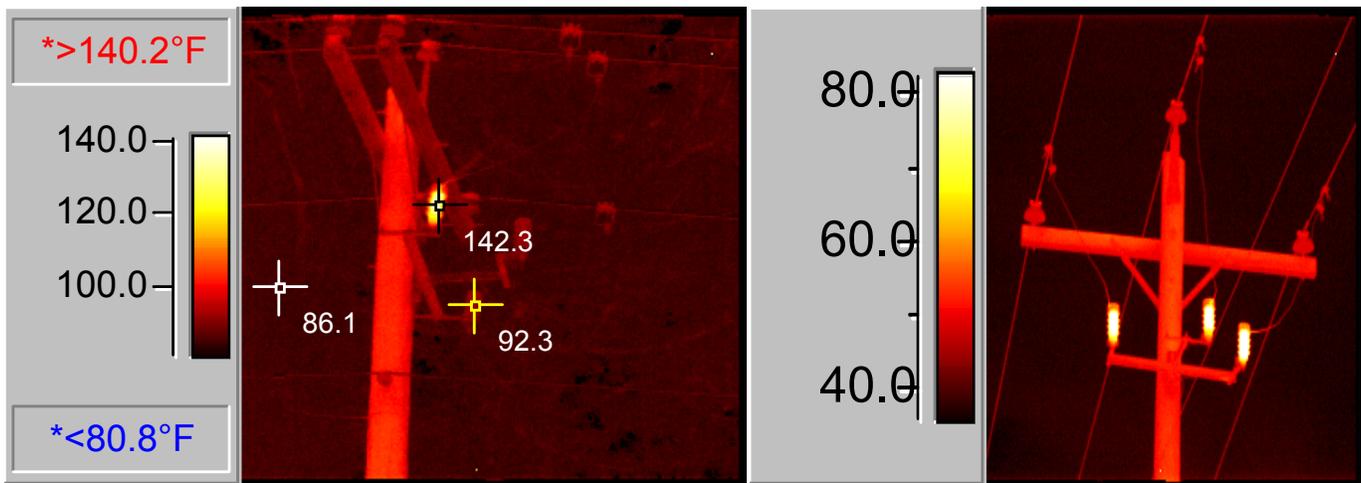
“HOT” Lightning arresters is a label I gave the arresters because it was an easy way to track and distinguish the good ones from the bad ones using the infrared camera. Through investigations I have discovered that the MOV (Metal Oxide Varistor) non-gaped are the only line arresters showing heating while in service. The old porcelain type arrester and the new porcelain gap type do not show heat. The main reason for using the MOV non-gap arrester was for the purpose of not operating the breaker at the substation. The MOV would conduct letting the surge of current go to ground and not operating the breaker. The type of MOV non-gaped arrester that we are looking at has a 22 cartage without the primer in the in the bottom of the MOV where the stud bolt is and the ground wire attach to the lightning arrester. When lightning strikes the line the MOV arrester shorts the high current to ground. The high current of lightning is used as the primer to activate the powder and blow the ground stud out of the unit and should not operate the breaker at the substation. What we are seeing is the MOV showing “Hot” on the pole. This implies the MOV is conducting current through the MOV arrester and the current is proportional to the temperature. We suspect the powder is wet or deteriorated and will not blow the ground stud out of the arrester base, therefore letting the arrester leak excessive amount of current through the MOV. We have employed an independent research laboratory to do further testing so that we can come up with a solution to the problem. Below (figure 1) are two examples of “Hot” lightning arresters in the field in service. The left picture shows ambient temperature at 86deg F., two of the lightning arresters at 92deg. F. and the “Hot” lightning arrester at 142deg. F.

Figure 1. Examples of “Hot” lightning arresters in the field in service

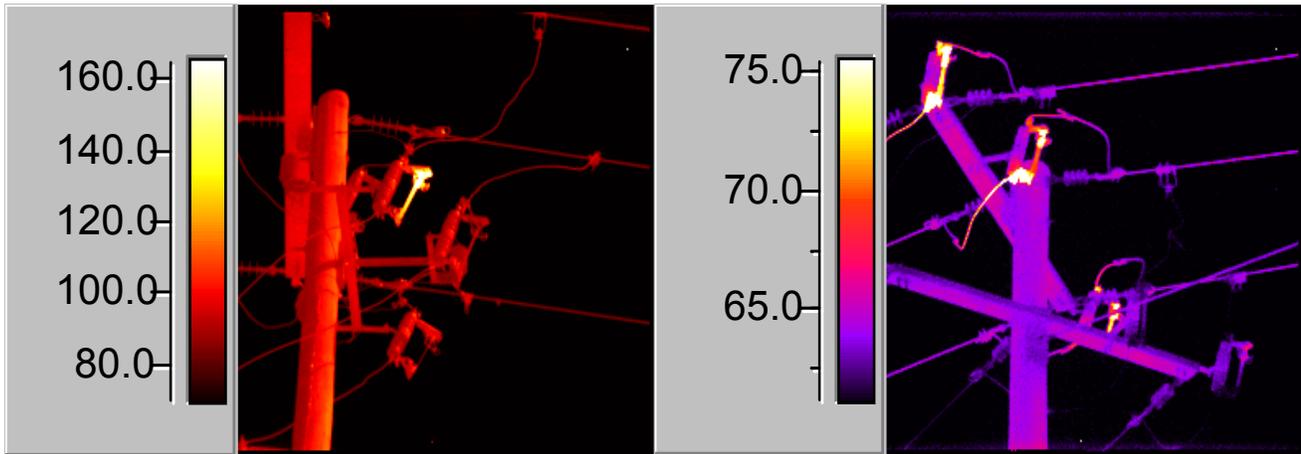
Fused Cutouts were found to be 10% of all problems identified. Two problems were found with the cutouts, loose hardware and overheating of the fuse barrel cap. Loose hardware occurred during installation or was loose from the factory and not detected. Overheating of the fuse barrel caps occurred from improper installation of the fuse cap on to the fuse barrel. This problem incurred by the way the cap was tightened down on the fuse barrel before the fuse was installed in the cutout. If the fuse cap was tightened by hand with gloves on, holding the barrel in one hand and tightening the cap with the other hand, the cap could not always be tightened properly. Therefore if the fuse cap was loose it would began arcing, causing heat and eventually melt the fuse, causing the fuse barrel to fall open. A better method to tighten the cap on the fuse barrel is to secure the barrel in holding device and use pliers to tighten the cap down securely.

Second, some of the 200amp-fused cutouts had a design problem. The manual stop was not properly set. The manual stop was set too far back, therefore letting the fuse overlatch which greatly reduced the amount of current carrying capability of the cutout. This resulted in the fuse cap overheating and causing the fuse to melt out. By moving the manual stop toward the fuse barrel one fourth of an inch this would eliminate the problem. **Figure 2** illustrates two examples of fuse related problems.

Figure 2. Examples of two fuse-related problems

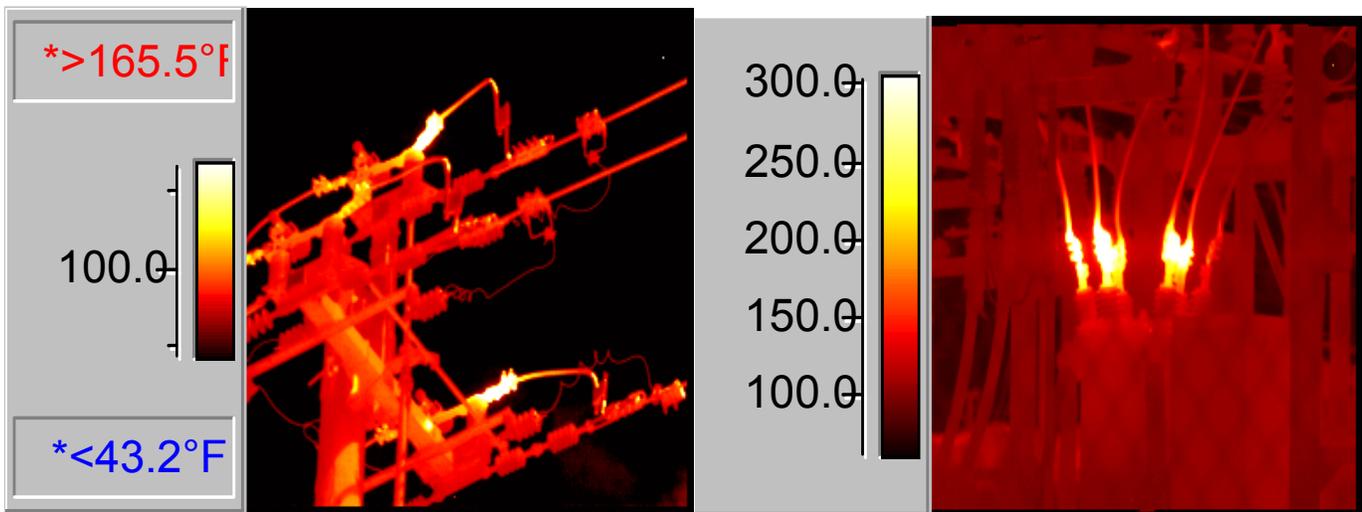
Connections were about 25% of the problems found. These were bad connections due mostly to human error. Some of the reasons were weather, heat, improper tools for the job, improper connections of metals and rushing to get power restored as soon as possible to the customer. Making people aware of these improper connections and through training, we have been able to greatly reduce this problem. If a connection is not made properly it will eventually cause an outage or interrupt power service to our customers, which in turn cost our customers and us. The severity of the problem depends on where the problem is located, whether in a substation, on our distribution lines or on the customers distribution system. Figure 3 illustrates two pictures of connection problems.

Figure 3. Examples of two connection-related problems

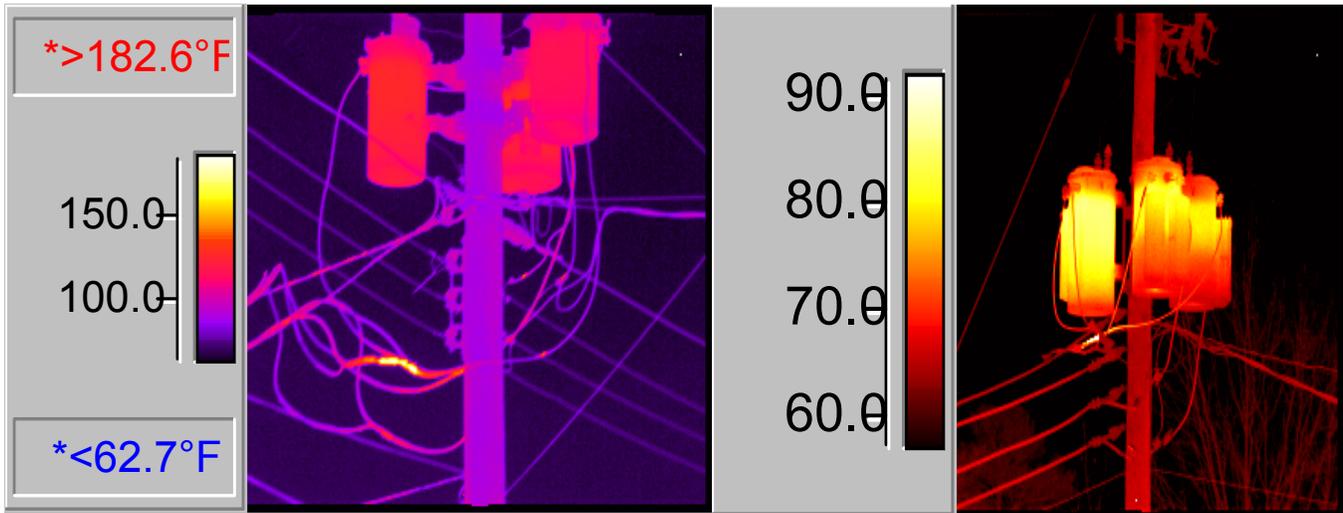
Compression Crimps were about 20% of the problems found on distribution lines. There are several reasons for the causes of these hot spots. They include the wrong size compression crimps used, wrong dye in crimping tool, crimping tool out of adjustment and improper crimping. By bringing these problems to their attention and with better awareness by the people doing the work, many of these problems can be eliminated. **Figure 4** illustrates two examples of compression crimp problems.

Figure 4. Examples of two compression crimp -related problems
