Generator step-up transformer, low voltage bushing overheating event

Richard Bjornson

Seabrook Nuclear Power Station, Seabrook, NH

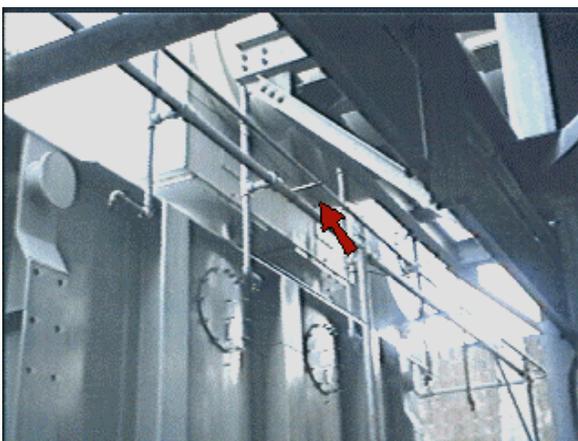
Fig.1 is a visual image of the "A" Phase Generator Step-Up Transformer, Low Side Bushing Compartment. Fig.2 is the corresponding thermal image. The 250°F temperature measured on the surface of the bushing compartment exists because of heat being generated inside the compartment. The source of the heat was suspected to be a high resistance connection between the low side bushing and the isophase. Recognizing that a significant heat source would be needed to raise the surface temperature of the compartment to 250°F, it was suspected that there was potential for a catastrophic transformer failure.

Figure 1 Visual image of the "A" phase generator step-up transformer

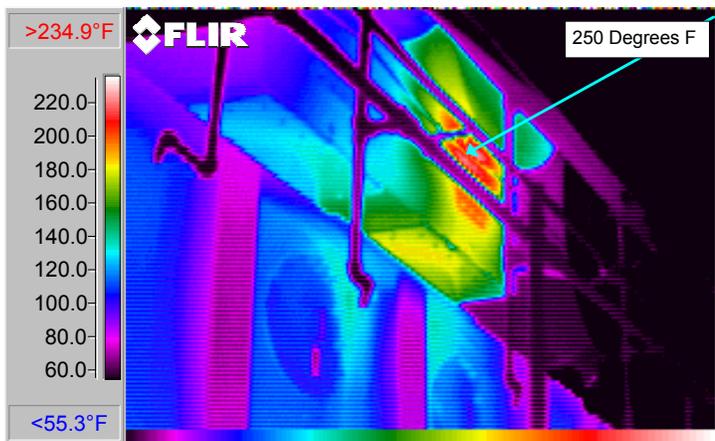
North Atlantic Energy Service was performing a routine thermographic inspection as part of the self-assessment program at Seabrook Nuclear Station, a 1200 megawatt nuclear power generating facility in New Hampshire. What appeared to be a serious temperature rise was detected on a 25kV to 345kV Generator Step-up "A Phase" Transformer. The location was on an Isophase-to-Low-Side bushing where an apparent temperature rise of 150°F was detected on the surface of the bushing compartment.

Figure 2 Corresponding thermal image of the transformer

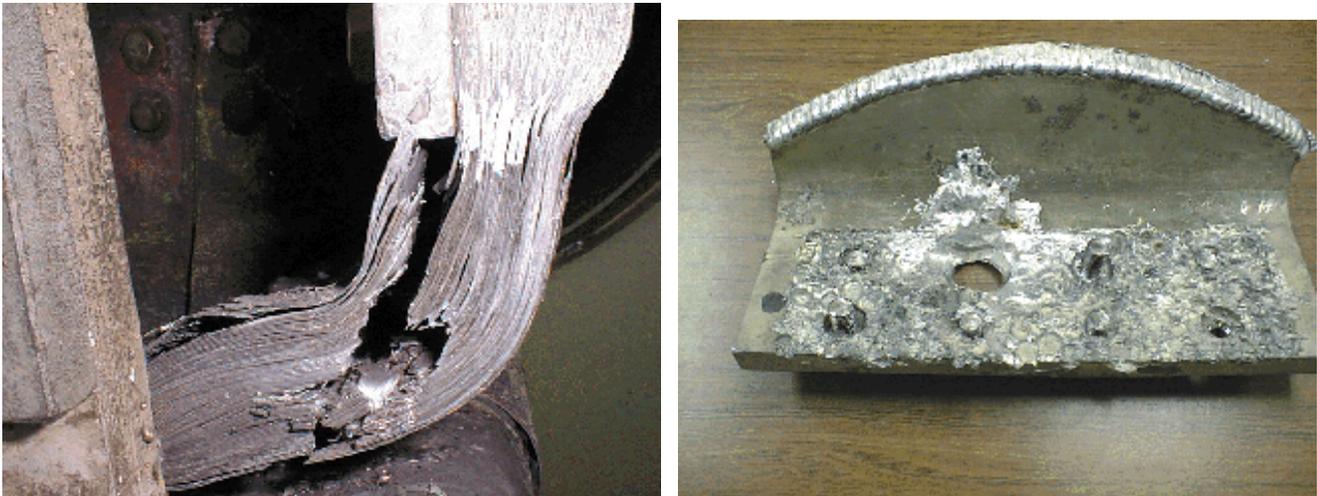
An inspection of the inside of the bushing compartment revealed significant damage, including substantial melting and deterioration of the bushing and surrounding components. These components had been exposed to extremely high temperatures. The melting temperature of aluminum is approximately 1220°F. Fig.3 illustrates some of the damage sustained by the transformer bushing links.

Figure 3. Photographic illustration of some of the damage sustained by the transformer bushing links

- Actual Event - In actuality, the situation was detected by a PdM diagnostic program and repairs were made. The unit was put back into service after an outage of 12.2 days.
