Lightning arresters' effect on power line reliability

Richard Strmiska

Sumter Electric Cooperative, Inc., P.O. Box 301, Sumterville, Florida 33585-0301

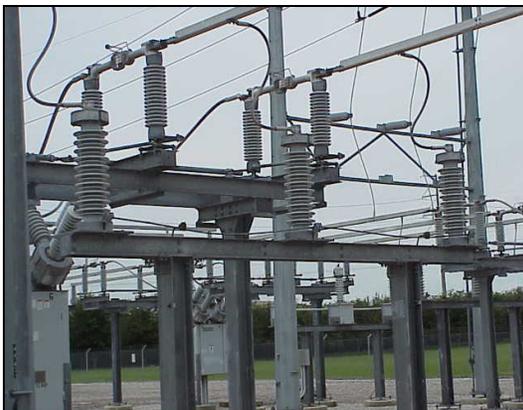
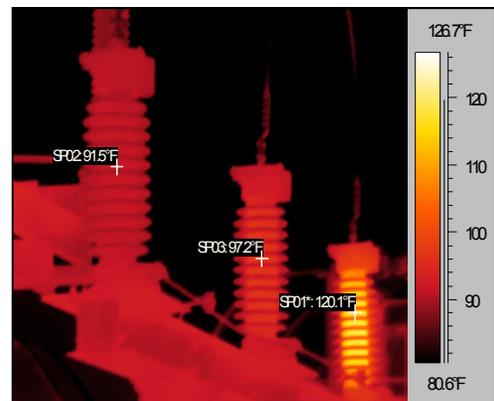
Figure 1. Failure of a 69 kV lightning arrester. This problem could have affected reliability of this power system by causing an outage to several thousands of consumers being served by this substation.

These types of lightning arresters are used in substations to protect the station and equipment from incoming surges due to lightning and almost any type of fault current. The data in the picture show the elevated temperature of the hot arrester in question. Failure of this type of arrester could affect a large number of consumers due to the size of these substations and where they are located. The picture below is an example of a hot 69 kV MOV arrester.

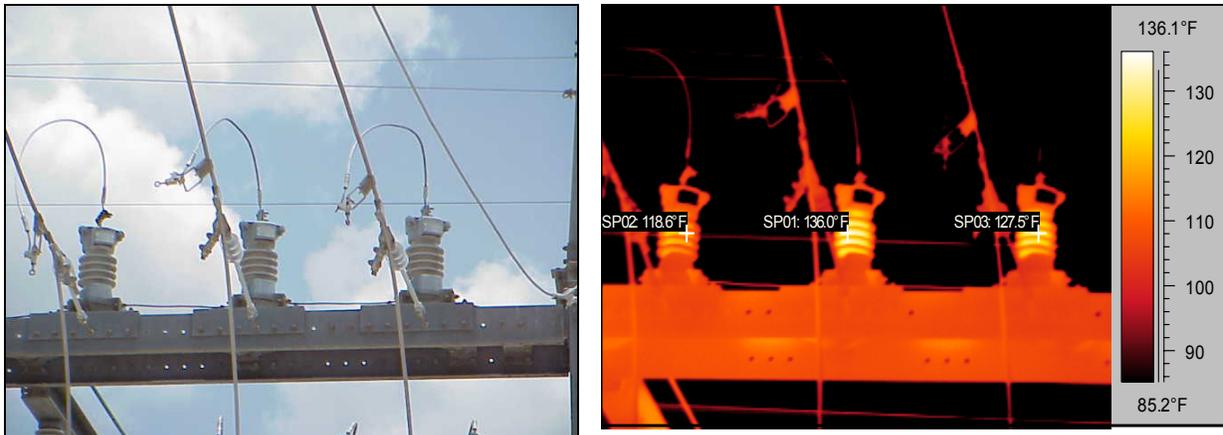
Figure 2. The heating problem with these arresters could have affected the reliability of this three phase feeder line. Feeder lines such as these serve 2,550 consumers.

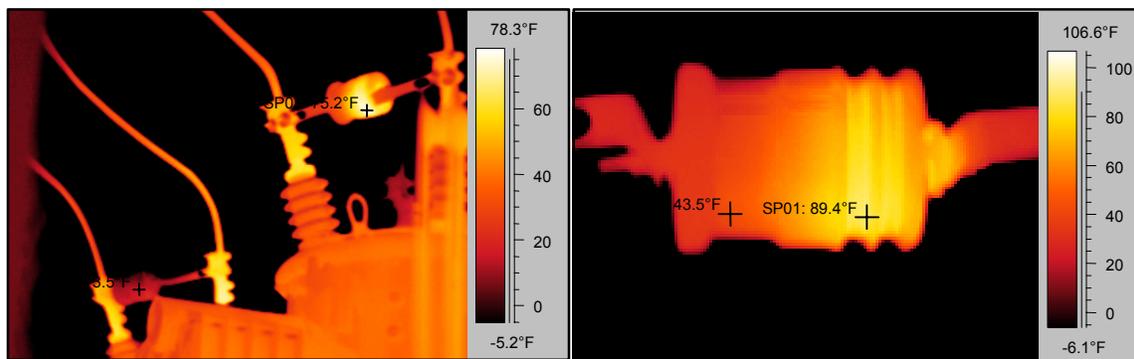
Figure 3. This problem arrester on the voltage regulator upon failure could have affected the reliability of the regulator and/or the total substation. This substation serves a total of 2,120 consumers.

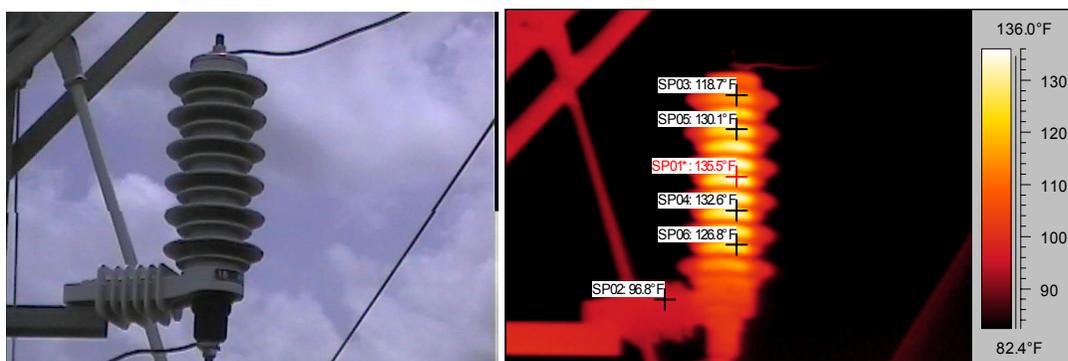
This 18 kV type lightning arrester, along with the 9 kV lightning arrester, has affected the reliability of our distribution system the most. The buildup of heat due to internal moisture or block failure enables the arrester to dump high amperage to ground if the isolator does not blow causing the substation breaker to relay the distribution line which now has affected reliability of power to the consumers

Figure 4. The thermograph shows a high amount of heat present within the arrester, thus causing the feeder to relay open. This also holds true for fused taps. The next page shows examples of the tests on returned lightning arresters that showed up hot on the distribution lines.

All intact stacks were heated in an oven at 120°C for 36 hours to drive out potential absorbed moisture. The measurements before and after treatment are listed in Table 1. The conclusion was that water ingress decreases the resistance of the arresters, allowing more current to flow, causing heating, as illustrated in Fig. 4.
