## **Five uncommon component anomalies.**

Richard G. Strmiska

Sumter Electric Cooperative, Sumterville , Florida

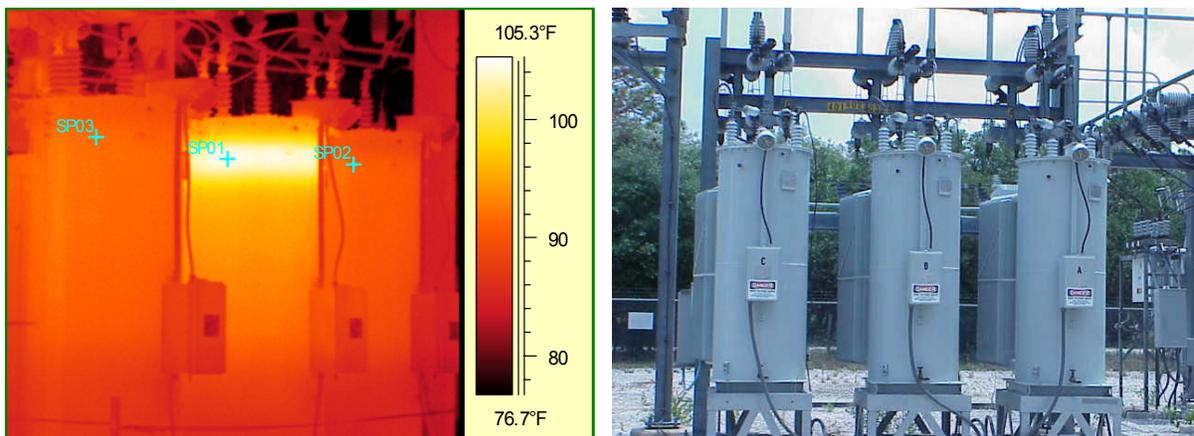
On an infrared inspection of one of forty distribution substations one of three voltage regulators showed a thermal signature to the top of the oil level down about a foot. A regulator is in all reality a step transformer. This means there are a number of taps into the coil that are utilized on demand, to rise or lower a base line voltage. This is accomplished basically with a tap changer board, a motor, and a control panel. With the demand for a change in voltage the sensing section of the control panel calls for the motor to move the tap changer. This will pick up the available points of voltage on the tap changer board. Thus causing the voltage to change up or down which ever demanded on the distribution line.

Inspection by a service tech found that the voltage regulator would not step to raise or lower the voltage. A faulted component inside the electronic control panel had failed. This failure sent a mixed signal to the stepping motor to raise and lower the voltage at the same time. Thus the motor became overheated and non-functional and non-stepping causing the oil to heat which produced this thermal signature.

**Figure 1 Thermogram (left) and photo (right) of three regulators. The motor in the middle regulator is overheating.**

<b>Date of creation: 10/9/2001</b>	<b>IR information</b>
<b>Time of creation: 12:34:40 PM</b>	
<b><u>Label</u></b>	<b><u>Value</u></b>
<b>SP01</b>	<b>105.2°F</b>
<b>SP02</b>	<b>91.4°F</b>
<b>SP03</b>	<b>92.0°F</b>
<b>Delta – T</b>	<b>13.80</b>

The importance of this regulator on the system made it imperative to replace this piece of equipment in order to keep the voltage stable to the customer. This problem with the regulator could also lead to other problems with a possible lose of the regulator it self. The valued cost of this regulator is \$16, 830.00. **Figure 1** displays the thermogram (left) and the photo (right) of the regulator in question. **Table 1** lists the parameters of the thermogram.

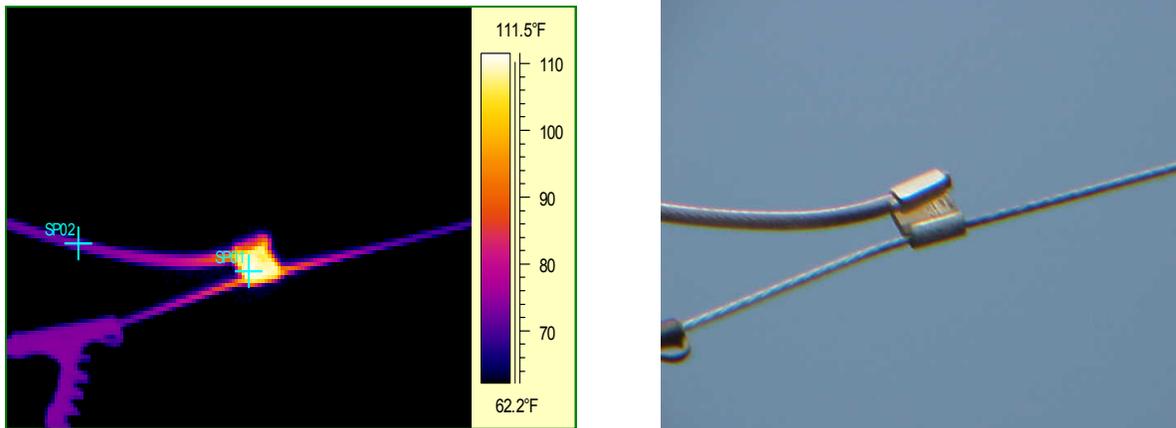
During a routine monthly infrared inspection of a distribution substation, a wedge connection appeared as a hotspot on the incoming 69 kV transmission line to the power substation. A 2/0 jumper from the 69 kV disconnect switch to the incoming 1/0 line was connected by a 2/0 to 2/0 wedge connector. This type of connection is a common connector used for this kind of application. The problem being is the use of a wrong size connector. A 2/0 to 1/0 connector is the proper connector, which at a later date replaced the improper connection, caused a loose fit of the jumper wire connection to line.

If the problem were not corrected the jumper connection could burn up. This could cause the substation to single phase with only two phases serving power, as this was a 69kV-fused substation. This would cause an unbalance condition to the consumers until the main 69 kV breaker feeding the transmission line relayed open. This breaker serves other substation on this transmission line, if opened this would be considered a large outage of power to the consumers. This is shown to be an improper installation with the wrong size wedge connector with a connector cost of \$1.98. **Figure 2** shown below shows the wedge connector anomaly. **Table 2** lists the parameters of the thermogram.

**Figure 2, Thermogram (left) and photo (right) of a failing wedge connector**

<b>Date of creation: 7/12/2001</b>	<b>IR information</b>
<b>Time of creation: 3:323:58 PM</b>	
<b><u>Label</u></b>	<b><u>Value</u></b>
<b>SP01</b>	<b>111.4°F</b>
<b>SP02</b>	<b>74.8°F</b>
<b>Delta – T</b>	<b>36.6°F</b>

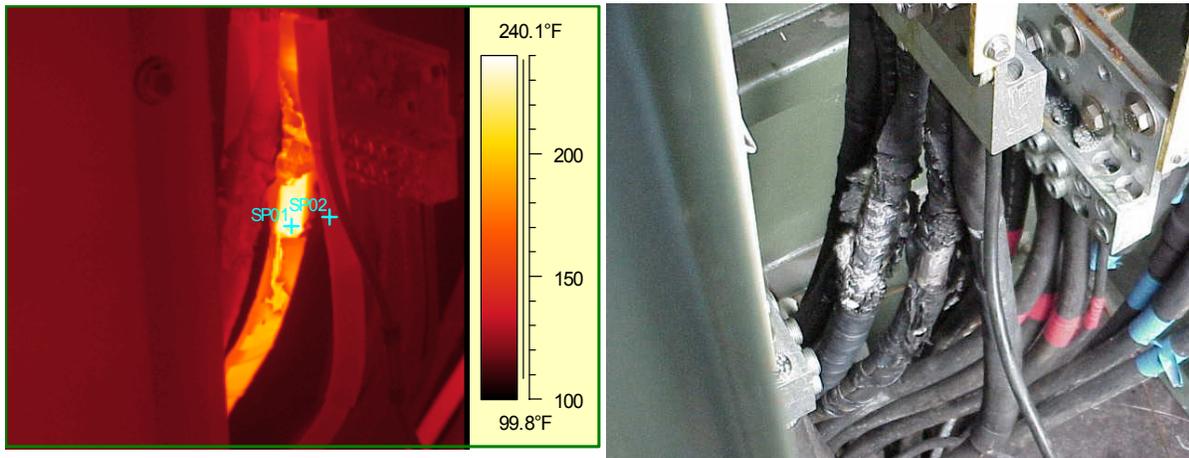
During a routine infrared inspection of a padmount transformer, the secondary side of the transformers 4/0 jacketed wire conductors showed a hotspot at a compression splice. Upon visual inspection it was noticed that another splice had been overheated. The anomaly (shown in the thermogram of **figure 3**) is due to the amount load on this wire at the time also the failure of the compression splice. The compression splice is copper with a plated coating. The coating more than likely deteriorated due to the crimping and the load heat on the wire conductor. At this point corrosion began to build up between the copper splice and the aluminum wire causing a poor connection in the splice. **Table 3** lists the parameters of the thermogram.

**Figure 3. Thermogram (left) and photo (right) of a copper connector splice to aluminum wire**

<b>Date of creation: 3/29/2002</b>	<b>IR information</b>
<b>Time of creation: 2:39:50 PM</b>	
<b><u>Label</u></b>	<b><u>Value</u></b>
<b>SP01</b>	<b>239.3°F</b>
<b>SP02</b>	<b>128.0°F</b>
<b>Delta – T</b>	<b>111.3°F</b>

This problem could have been avoided if an aluminum splice had been used at a cost of \$31.00 per splice. This consumer's problem cost \$4500 to replace all bad wires with splices from the secondary side of the transformer to their main panel boxes with new wire thus eliminating all splices

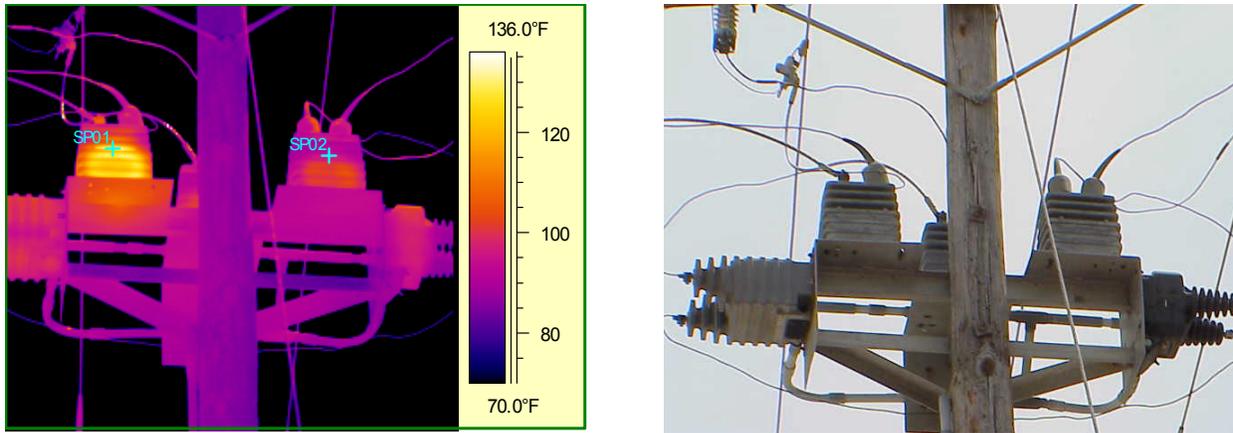
On a yearly infrared inspection on a feeder circuit line one of the current transformers on a three-phase service to a sandmine appeared to be hot as can be seen in the thermogram of **figure 4**. There are three current transformers one for each phase serving this sandmine. A Current Transformer or CT as they are sometimes called monitor the amount of amperage or load per phase a customer is using. These are a necessity in order to bill a customer for electricity usage. **Table 4** lists the parameters of the thermogram.

**Figure 4. Thermogram (left) and photo (right) of an overheated current transformer (left of picture)**

<b>Date of creation: 4/11/2002</b>	<b>IR information</b>
<b>Time of creation: 11:28:22AM</b>	
<b><u>Label</u></b>	<b><u>Value</u></b>
<b>SP01</b>	<b>136.0°F</b>
<b>SP02</b>	<b>96.0°F</b>
<b>Delta – T</b>	<b>40.1°F</b>

By locating this problem we were able to schedule a time to remove the bad current transformer due to a probable internal failure. This averted an outage due to a complete failure to this current transformer cluster mount. The cost of a 600:5 ratio current transformer is \$177.00.

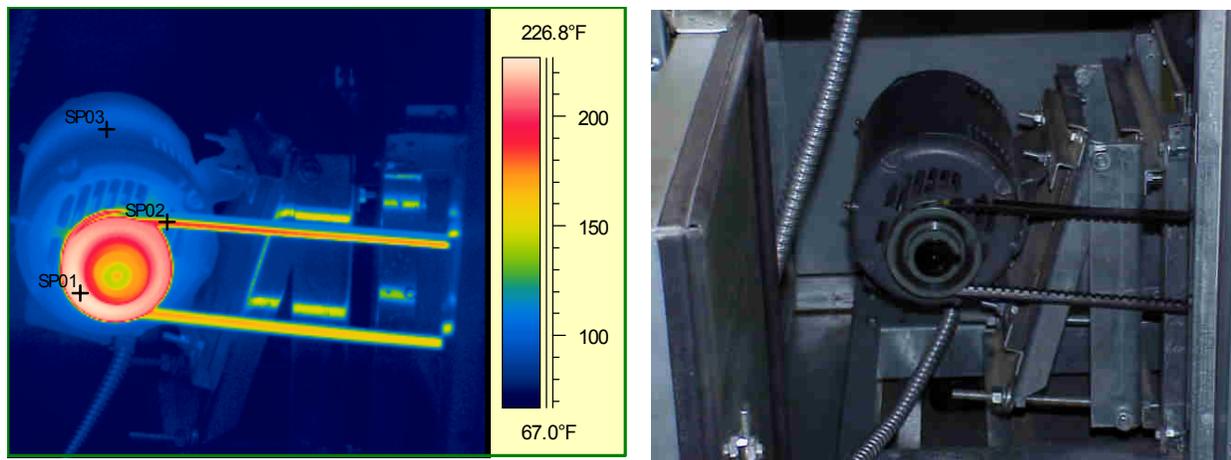
We had the opportunity to do an infrared survey for the school systems in the local counties. The surveys included ten schools. We were able to look at all electrical and mechanical equipment. There were a total of 120 air conditioner air handlers and fans inspected. Each air handler consists of a motor and belt and fan unit to move the chilled air through out the school area. The problem in question is in the rubber belts that run from the motor pulley to the air handler pulley. These belts are three and a half feet long from pulley to pulley. In the visual picture of **figure 5** below can be seen notches on the inside of the belt This type of belt is made to fit better in the pulleys groove but was found to stretch more quickly. Upon further inspection it was discovered that another style of belt was also being used. This was a belt with no grooves in the belts running surface. It was found that about thirty air handlers had the grooved type of belts in service. Only one unit showed excessive heat transferred to the motor pulley by a slipping belt. The heat range of the thermogram of **figure 5** below shows this. The motor pulley is acting as a heat sink. **Table 4** lists the parameters of the thermogram.

This IR survey showed that, according to past records, this grooved type of belt has been found to be slipping and to need more adjustments in less time than the other style of belt. The school’s maintenance supervisor decided to

If the grooved belt were left in place the efficiency of the air handler would be in jeopardy, possibly costing more money to run the air conditioners at these schools.

**Figure 5. Thermogram (left) and photo (right) of an overheated air conditioner belt and pulley**

<b>Date of creation: 5/15/2002</b>	<b>IR information</b>
<b>Time of creation: 9:21:08A M</b>	
<b><u>Label</u></b>	<b><u>Value</u></b>
<b>SP01</b>	<b>226.7°F</b>
<b>SP02</b>	<b>175.2°F</b>
<b>SPO3</b>	<b>94.2°F</b>
<b>Delta – T</b>	<b>132.5°F</b>

change out all grooved belts on their scheduled repair dates, even though the grooved belt cost some \$3.00 less than the solid belt which cost \$15.80.
