Development of a utility feeder infrared thermography preventive maintenance program – with lessons learned

Michael A. Kregg
Senior Engineer and T&D Infrared Thermography Program Coordinator
ComEd Energy Delivery, Maywood, IL 60153

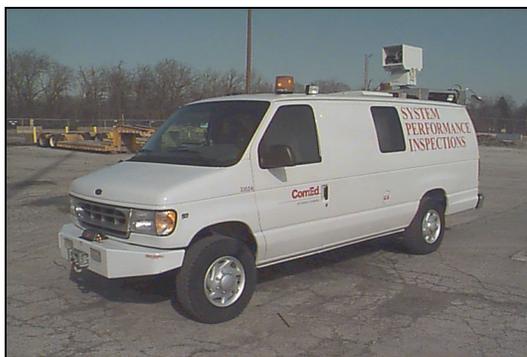
The vehicles are specially modified extended vans that accommodate the infrared scanning of an overhead distribution system. The outside of the vehicle has a front bumper winch, front and rear warning lights, roof hatch, roof deck with a camera pan & tilt unit mounted to it, left, right and rear quartz lights for illuminating potential work areas, rear arrow bar, and rear door ladder to the roof deck, (See figures 6 and 7 below).

Figure 6 Left side view of vehicle

Next, upon working with the vehicle, it became obvious that the placement of the light bar off the rear of the roof deck put the light bar in jeopardy of being broken. The light bar was therefore moved to under the roof deck for protection.

Other minor possible modifications to the present vehicles, and definite changes to all additional vehicles built have been suggested. These include: installation of strobe type warning lights, installation of LED type light bars, new placement of the cable hole in the roof deck to prevent damage from the pan & tilt of the camera box, and installation of cargo nets in the rear storage area to prevent the movement of equipment.

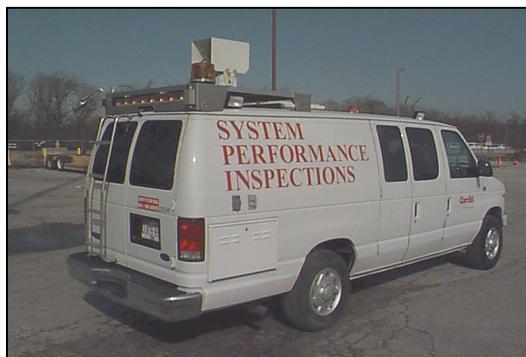
Figure 7 Right side view of vehicle

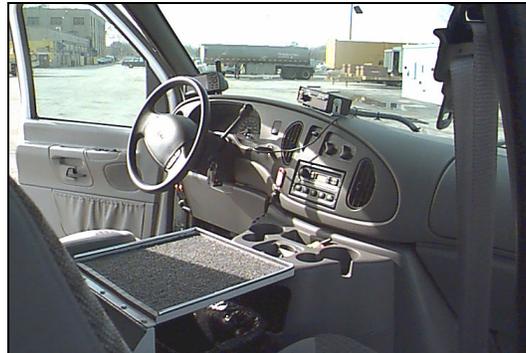
The driver's area has a GPS unit, controls for operating the warning lights and arrow bar, and a map compartment with fold up map table between the seats for storing and highlighting the map packages. All of the necessary office supplies for performing the driver's duties are stored in the engine cover console, (See **figure 8** below).

Figure 8 Driver's working console

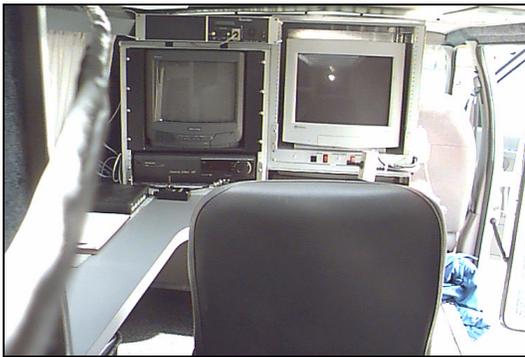
The thermographer's area has swivel chair, wrap around counter top, equipment racks (with TV, VCR, computer monitor, and keyboard), interior and exterior electrical system control panel, 12VDC lighting system, and a variety of compartments, cabinets and drawers for equipment and supply storage. All of the necessary office supplies for performing the thermographer's duties are stored in a drawer organizer that has been Velcroed onto the counter top. Operation of the infrared and visual cameras on the roof deck are performed by remote control and positioned by a joystick controller, (See **figures 9 and 10** below).

Figure 9 Visual and IR monitors in thermographer's area

Another modification being worked on is the reorganization of the equipment racks. After having used the equipment for awhile, it was determined that some of the equipment is not utilized often and can be remotely located within the vehicle. Also, the use of flat screen monitors is being explored. The goal would be to have a pair of flat screen monitors vertically mounted behind the driver, with a very short and shallow equipment rack in front of the thermographer. This would help to improve the communications between the driver and thermographer, while possibly helping to alleviate some of the nausea experienced by many of the thermographers. (This modification would be accompanied by a rework of some of the vehicles electrical system.)

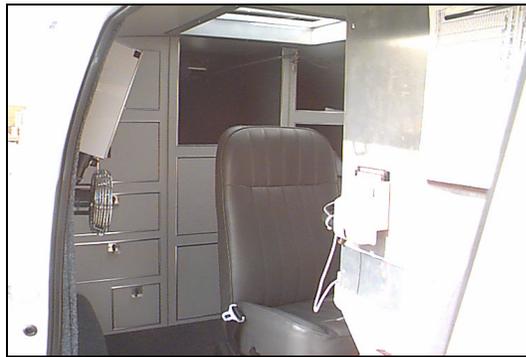
Figure 10 Thermographer's position

A safety issue that was expressed was the performance of lap belt on the rear seat. It was felt that this belt was not adequate for preventing the thermographer from coming in contact with the equipment racks in case of a collision. Therefore, we are pursuing developing a 4 or 5 point harness system for the rear seat that would greatly reduce the thermographer's movement during a crash.

An ergonomic issue that was brought up was the placement of the current joystick control for the pan & tilt unit. The joystick is presently located on a flexible arm that is attached to the equipment rack and extends towards the thermographer. This requires that the thermographer reach out to operate the pan & tilt unit which becomes tiring after 8 hours of operation. Therefore, flip up arm rests with an attached bracket will be installed on the rear swivel chair. Once the thermographer is seated, he will be able to fold down the arm rests and Velcro the remote joystick to the bracket. This will allow him to operate the pan & tilt unit while resting his arm on the arm rest, reducing fatigue.

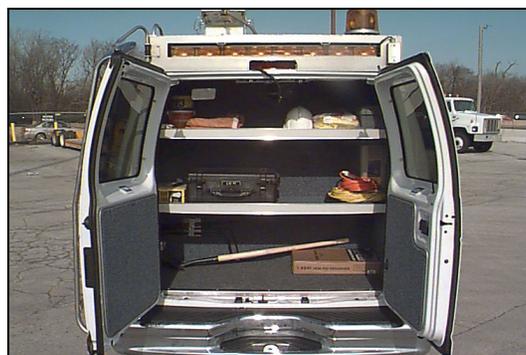
Inside the rear doors of the vehicle are selves for equipment storage, as well as the vehicles special 12VDC charging system and 110VAC inverter system, (See **figure 11** below).

Figure 11 Storage area , charger and inverter
